BOA Architecture / Government Services
Rancho Palos Verdes ADA Assessment

Facility Report with Photos - Programs Services

Facility ID: # 02B - City Hall Buildings

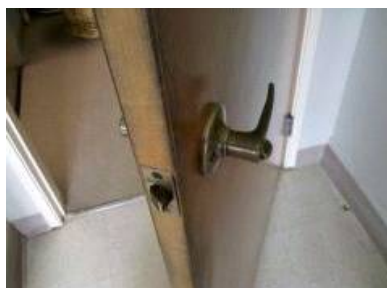
16.10 - Single-Action Hardware - Handles, locks, and latches or other operative devices are not operable with one hand. OR They are not operable without tight grasping, pinching, or twisting of the wrist. (U-shaped handles, levers, and push/pull type mechanisms are acceptable designs.)

Existing Condition: Twist-type locking mechanism.

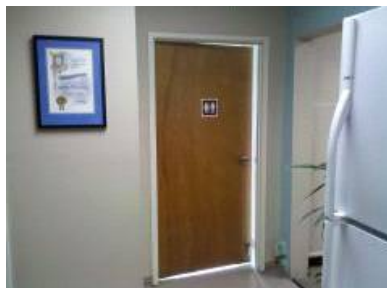
16.13C - Unisex RR Geometric Symbol Signage - Circle/Triangle - Doorway leading to a unisex toilet room is not identified by a 12" circle, 1/4" with a 1/4" thick triangle superimposed and within the circle. OR Circle and triangle are provided, however they are accompanied by words in raised characters and Braille. (ADA and CBC Standards require a separate sign with raised characters and Braille mounted on the wall adjacent to the latch side of the door.)

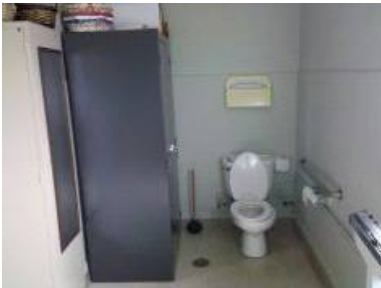
Existing Condition: 18" to non-fixed furniture.

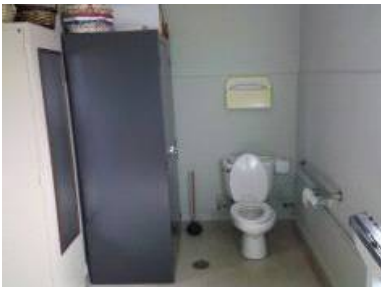
Existing Condition: 16" AFF.

323A - Replace Toilet Seat - Remove existing toilet seat and retrofit a new toilet seat so that the top of the seat is 17" to 19" above finish floor.

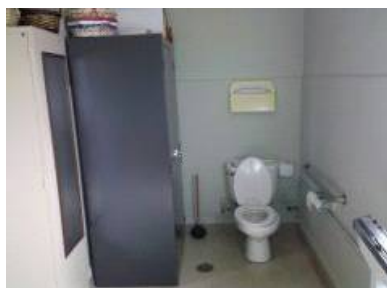
Existing Condition: 40 1/2" from back wall.

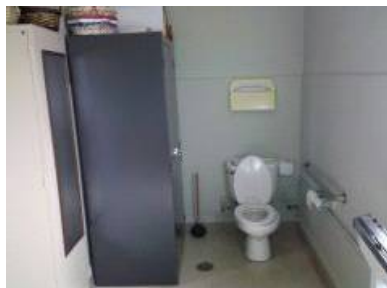
Existing Condition: 56" AFF.

294C - Relocate Dispenser - Relocate existing dispenser on an accessible route. Patch and repair wall substrate and finishes, to match adjacent undisturbed surfaces.

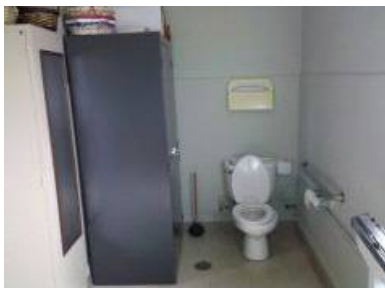
Existing Condition: Rear grab bar not provided.

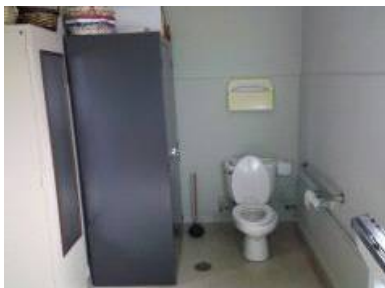
Existing Condition: 37" long.

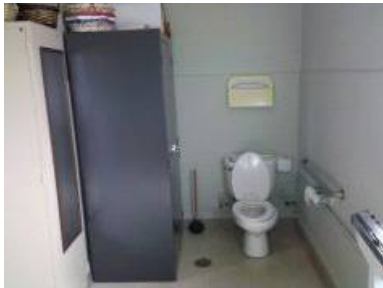
Existing Condition: 29" AFF.

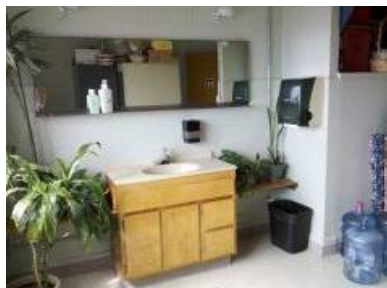
Existing Condition: 52 1/2" AFF.

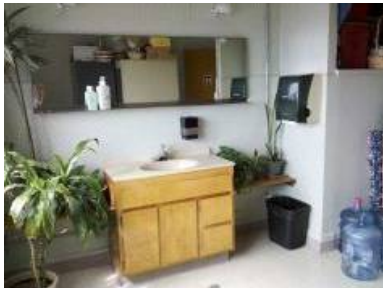
Existing Condition: 52 1/2" AFF.

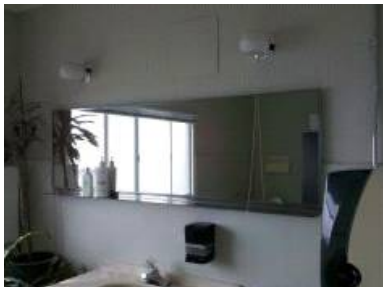
Existing Condition: Lights above mirror require grasping to power on.

031B - Replace Control - Replace control. Repair/refinish as required.

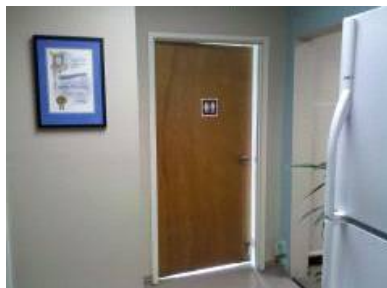
11.15A - Kick Plate - Bottom 10" of door does not have a smooth, uninterrupted surface on the push side to allow the door to be opened by a wheelchair footrest without creating a trap or hazardous condition. (This requirement does not apply to automatic and sliding doors.)

Existing Condition: Door stop.

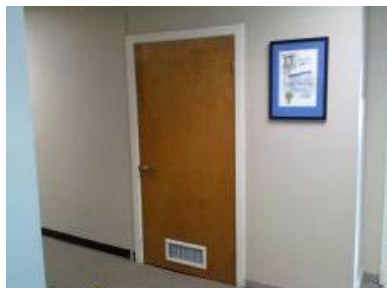
Existing Condition: Door jamb at 77 1/4" AFF.

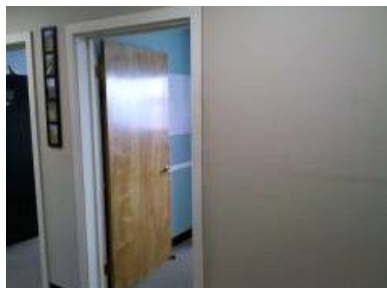
11.17A - Recommendation: Providing Room/Space ID Sign - A sign designating the permanent room or space has not been provided.

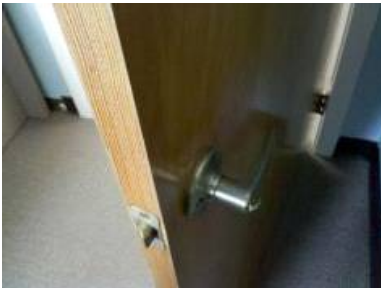
11.11 - Single-Action Hardware - Handles, locks, and latches or other operative devices are not operable with one hand and without tight grasping, pinching, or twisting of the wrist. (U-shaped handles, levers, and push/pull type mechanisms are acceptable designs.)

Existing Condition: Twist-type locking mechanism.

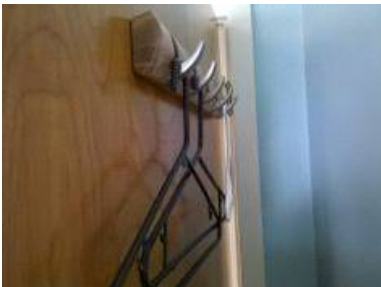
14.32A - Reach Range - Controls - Controls, dispensers, and similar devices are not between 9" and 54" AFF when the clear floor space allows a parallel approach. OR They are not between 15" and 48" AFF when the clear floor space allows only a forward approach.

Existing Condition: Coat hook at 67" AFF.

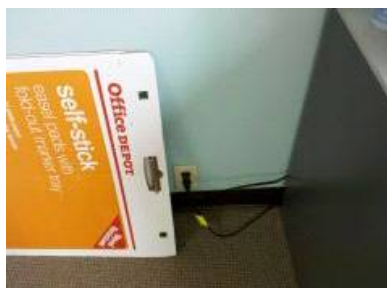
Existing Condition: 2 power outlets.

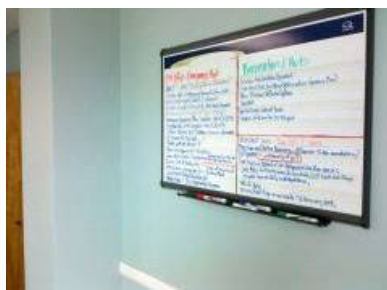
Existing Condition: Dry erase board at 51 1/2" AFF.

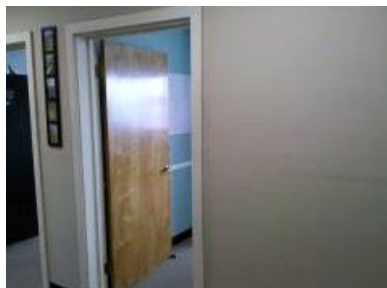
Existing Condition: Door jamb at 76 3/4" AFF.

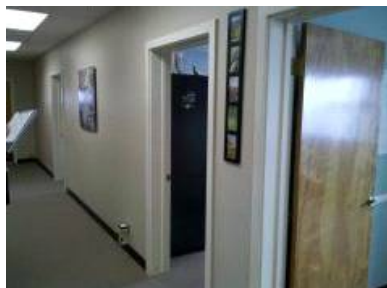
11.17A - Recommendation: Providing Room/Space ID Sign - A sign designating the permanent room or space has not been provided.

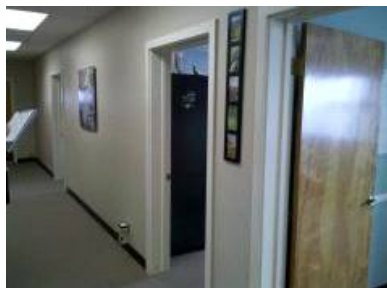
Existing Condition: Door jamb at 77" AFF.

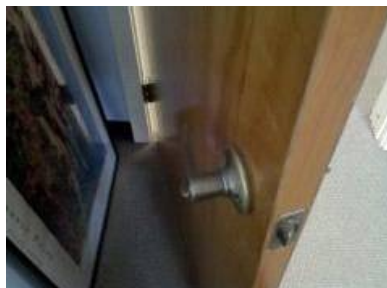
Existing Condition: Twist-type locking mechanism.

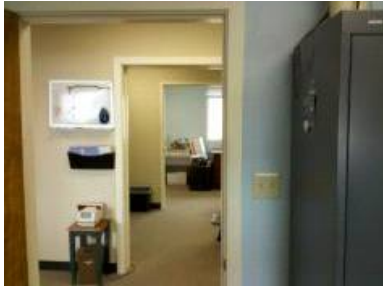
11.06A - Door Maneuvering Space - Door that is not automatic or power-assisted does not have compliant maneuvering space relative to the direction of approach as shown in CBC Fig. 11B-26. (Approach // Side // Width // Depth) (Front // Pull // D + 24" * // 60") (Front // Push // D + 0" ** // 48") (Latch // Pull // D + 24" // 60") (Latch // Push // D + 24" // 44" ***) (Hinge // Pull // D + 36" // 60") (Hinge // Push // 54" **** // 44" *****) (* D + 18" at interior doors.) (** D + 12" if door has both a latch and a closer.) (***) 48" if door has closer.) (**** Measured from latch toward hinge.) (***** 48" if door has both a latch and a closer.)

Existing Condition: 11" to non-fixed furniture, pull side.

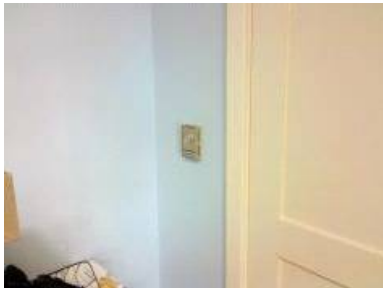
14.35 - Controls - Operation - The controls are not accessible. (Accessible controls shall be operable with one hand, and without tight grasping, pinching, or twisting of the wrist, and the force to operate the controls shall be no greater than 5 lbs.)

Existing Condition: Twist-type thermostat.

031B - Replace Control - Replace control. Repair/refinish as required.

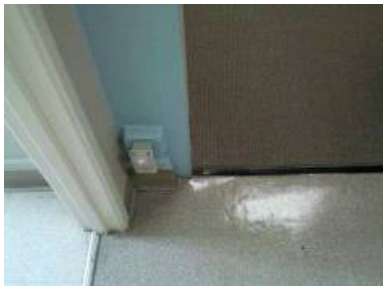
14.32A - Reach Range - Controls - Controls, dispensers, and similar devices are not between 9" and 54" AFF when the clear floor space allows a parallel approach. OR They are not between 15" and 48" AFF when the clear floor space allows only a forward approach.

Existing Condition: 3 power outlets at 9 1/2" AFF.

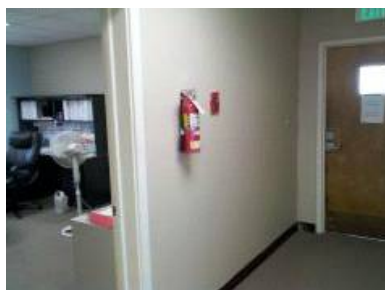
Existing Condition: 59" AFF.

388D - Relocate Fire Extinguisher - Relocate existing fire extinguisher. Repair and refinish.

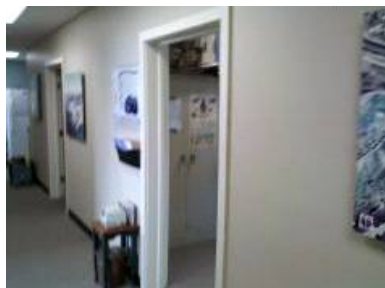
Existing Condition: Bottom of board at 54 1/2" AFF.

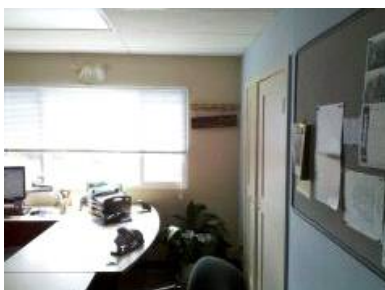
Existing Condition: Coat hook at 71" AFF.

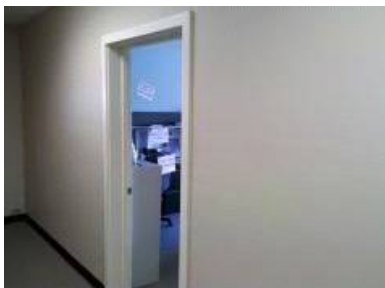
Existing Condition: Door jamb at 76 3/4" AFF.

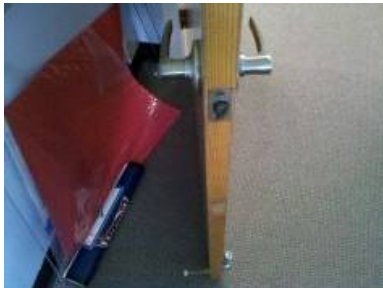
11.11 - Single-Action Hardware - Handles, locks, and latches or other operative devices are not operable with one hand and without tight grasping, pinching, or twisting of the wrist. (U-shaped handles, levers, and push/pull type mechanisms are acceptable designs.)

Existing Condition: Twist-type locking mechanism.

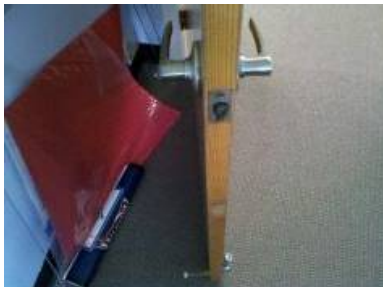
11.15A - Kick Plate - Bottom 10" of door does not have a smooth, uninterrupted surface on the push side to allow the door to be opened by a wheelchair footrest without creating a trap or hazardous condition. (This requirement does not apply to automatic and sliding doors.)

Existing Condition: Door stop.

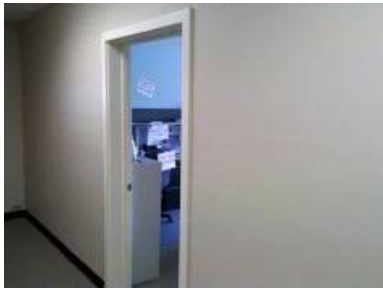
11.17A - Recommendation: Providing Room/Space ID Sign - A sign designating the permanent room or space has not been provided.

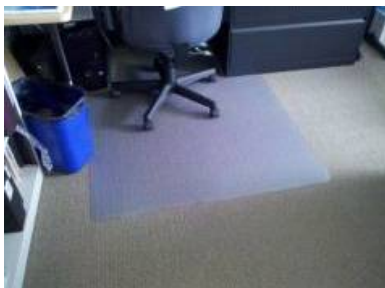
Keynote 732

14.23B - Floor Surface - Accessible route surfaces are not stable, firm and slip-resistant.

Existing Condition: Floor mat.

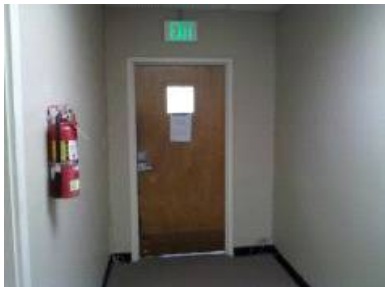
Keynote 733

14.31 - Head Room - Clear head room is at less than 80" within the pedestrian circulation area, including the accessible route of travel.

Existing Condition: Door jamb at 77 1/4" AFF.

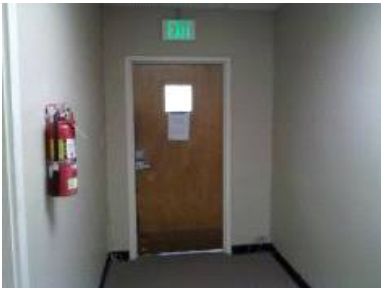
Keynote 734

11.15A - Kick Plate - Bottom 10" of door does not have a smooth, uninterrupted surface on the push side to allow the door to be opened by a wheelchair footrest without creating a trap or hazardous condition. (This requirement does not apply to automatic and sliding doors.)

Existing Condition: Door stop.

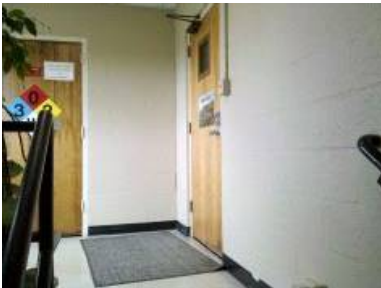
Keynote 736

Existing Condition: Floor mat.

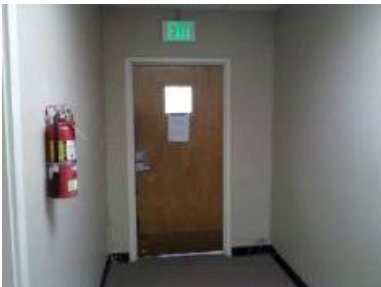
Keynote 737

Existing Condition: 12 LBF.

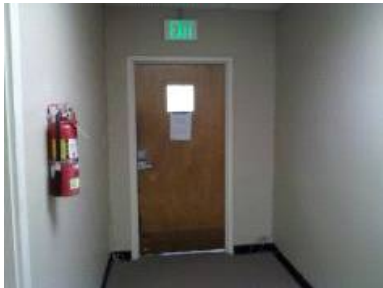
Keynote 738

Existing Condition: 59 3/4" AFF.

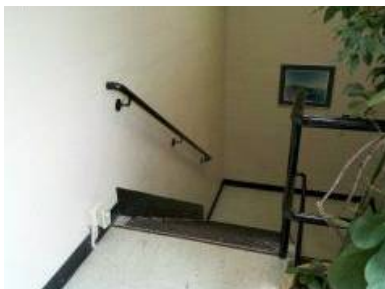
Keynote 741

14.32A - Reach Range - Controls - Controls, dispensers, and similar devices are not between 9" and 54" AFF when the clear floor space allows a parallel approach. OR They are not between 15" and 48" AFF when the clear floor space allows only a forward approach.

Existing Condition: 1 power outlet at 7" AFF.

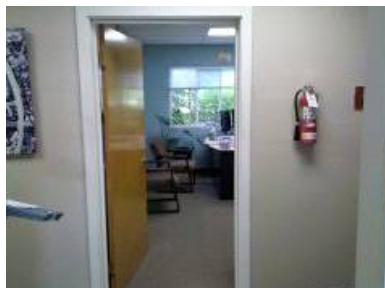
Keynote 743

11.17A - Recommendation: Providing Room/Space ID Sign - A sign designating the permanent room or space has not been provided.

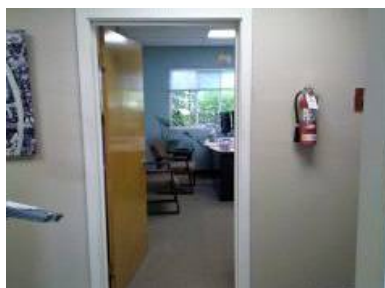
Keynote 744

Existing Condition: Door jamb at 77" AFF.

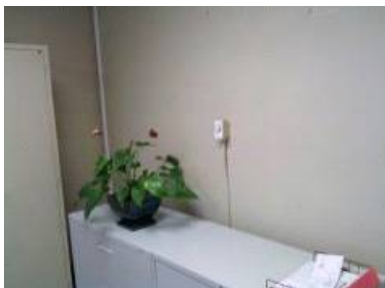
Keynote 746

14.35 - Controls - Operation - The controls are not accessible. (Accessible controls shall be operable with one hand, and without tight grasping, pinching, or twisting of the wrist, and the force to operate the controls shall be no greater than 5 lbs.)

Existing Condition: Twist-type thermostat.

031B - Replace Control - Replace control. Repair/refinish as required.

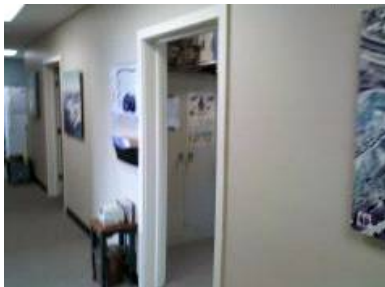
Keynote 747

14.31 - Head Room - Clear head room is at less than 80" within the pedestrian circulation area, including the accessible route of travel.

Existing Condition: Door jamb at 76 1/2" AFF.

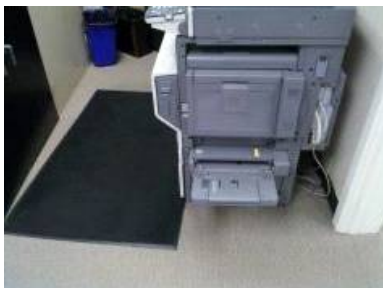
Keynote 748

Existing Condition: Floor mat.

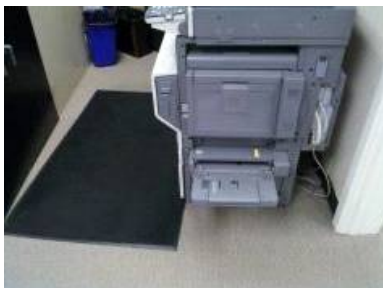
Keynote 749

Existing Condition: 3 power outlets, 1 data port at 9" AFF.

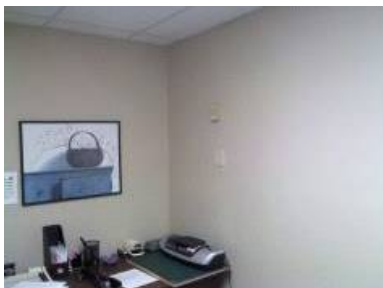
Keynote 750

Existing Condition: Twist-type thermostat.

031B - Replace Control - Replace control. Repair/refinish as required.

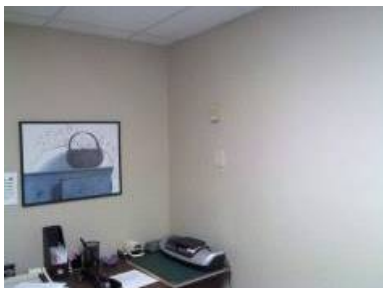
Keynote 751

Existing Condition: Thermostat at 60" AFF.

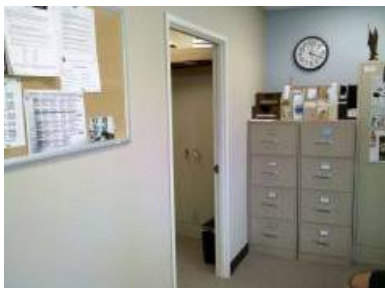
Keynote 752

Existing Condition: Door jamb at 76 1/2" AFF.

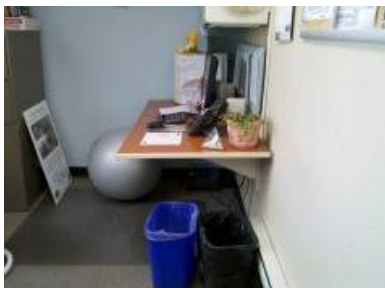
Keynote 753

Existing Condition: Floor mat.
